# Improvement of Base Ideality through Improved Surface Cleans

Freescale Semiconductor, Inc.

Tempe Fab

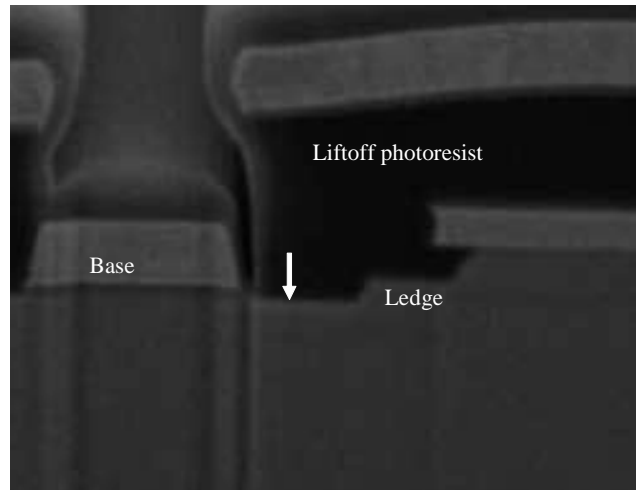
**Figure 1** SEM view of HBT after base metal deposition, prior to metal liftoff. Arrow indicates GaAs surface of interest, the region between base contact and ledge epi.

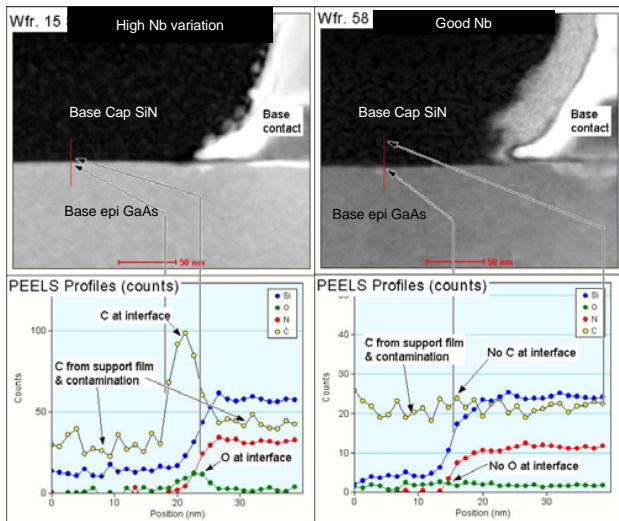
**Figure 2** PEELS line scans across surface passivation-GaAs interface for a site with higher Nb (left) and a sample with historical Nb. Note carbon and oxygen are detected at the interface of the sample with higher Nb.

Prior to running wafer-processing experiments, samples from sites already tested with higher Nb (causing overall increase in wafer standard deviation) vs. a historical value were analyzed by PEELS. Results revealed detectable carbon and oxygen at the surface passivation-GaAs surface interface on samples with higher Nb, where neither element was detected on samples with historical Nb (Fig. 2). Interpreting the carbon and oxygen in the PEELS spectra as originating from residual photoresist, we were directed toward a more aggressive post-liftoff photoresist clean.

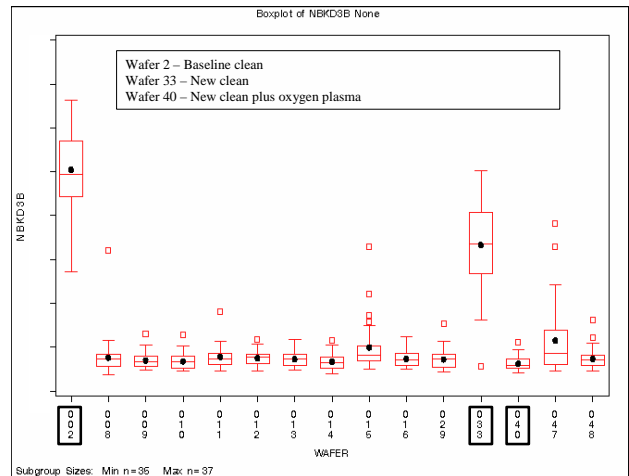
**Figure 3** Nb plots of wafers with known residual photoresist from baseline cleans (wafer 2), NMP-based photoresist clean (wafer 33), and NMP-based photoresist clean plus an oxygen plasma exposure (wafer 40). Note Nb improvements with NMP-based photoresist clean and return to baseline values with the addition of oxygen plasma.

Test results from the three wafers with extreme photoresist residue supported suppositions that our post-liftoff clean was marginal and that a more aggressive form of photoresist removal could recover wafers with even extremely high Nb values (Fig. 3).

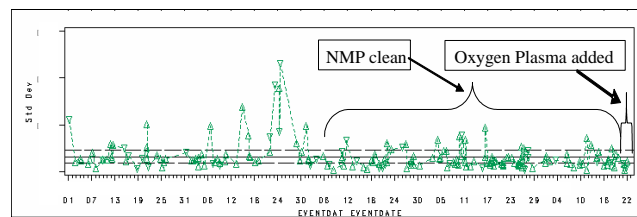
**Figure 4** Device trend chart for Nb standard deviation. Note that standard deviation was improved with the NMP-based photoresist stripper and further improvement was obtained with the addition of oxygen plasma.

Results from lot splits clearly demonstrated that implementation of the improved photoresist stripper reduced Nb variation and that a modification to the deposition tool would not be required (Fig. 4).

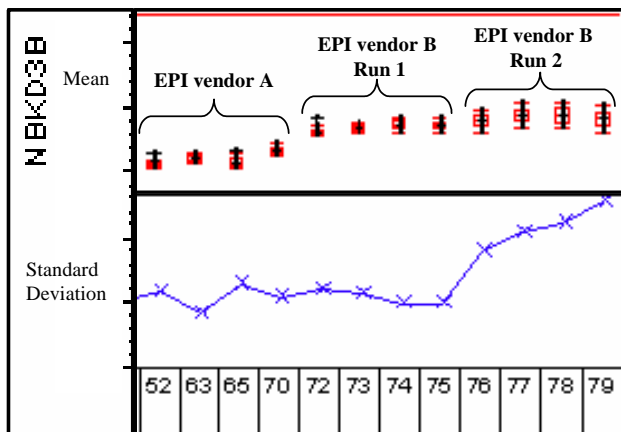
**Figure 5** Plot of Nb mean and standard deviation for a group of wafers with combined NMP-based photoresist stripper and oxygen plasma. Note epi vendors can be resolved by Nb means and that individual runs between the same epi vendor are distinguishable by standard deviation.

Additionally, the combination of a more aggressive photoresist stripper and oxygen plasma exposure has so dramatically improved Nb standard deviation (versus historical) that we can now distinguish between epi vendors and individual epi runs (Fig. 5).
